DIAGNOSIS GUIDE

TRANSMISSION CONTROL UNIT

ALL RELEVANT INFORMATION IN ONE GUIDE

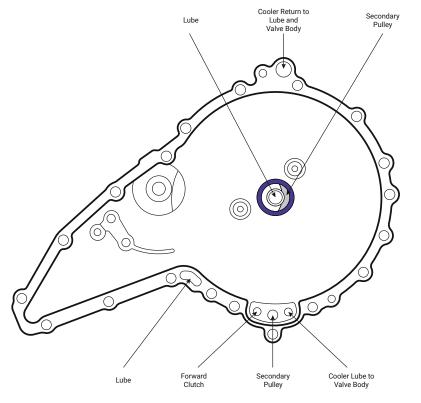
CRITICAL AREAS FOR MECHANICAL WEAR IN THE GEARBOX

If there is any contamination, check the gearbox thoroughly for mechanical wear/damage. The image below shows where the critical points are located.

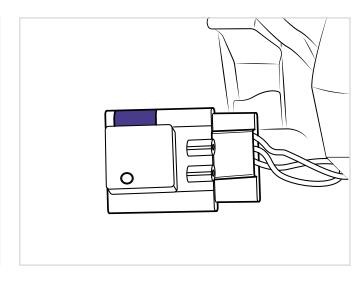
Removing the Mechatronic

- 1. Set the locking slider "2s" of the plug to the position shown above.
- 2. Press the lock "2v" and disconnect the plug.

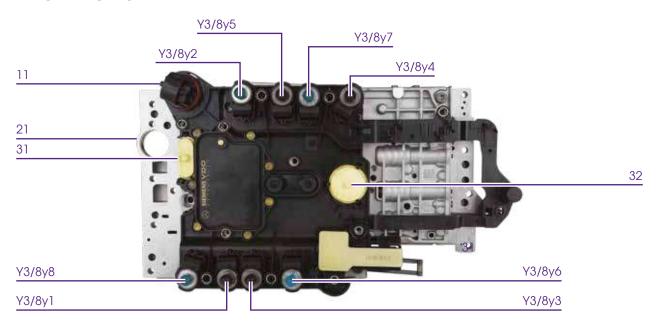
THE MECHATRONIC IN DETAIL

Part no.	Function
11	Plug
21	Hydraulic block / valve body, consisting of 2 parts and a partition panel
31	Oil level float 1
32	Oil level float 2
Y3/8y1	Control valve for general operating pressure
Y3/8y2	Clutch control valve K1
Y3/8y3	Clutch control valve K2
Y3/8y4	Clutch control valve K3
Y3/8y5	Brake control valve B1
Y3/8y6	Brake control valve B2
Y3/8y7	Brake control valve B3
Y3/8y8	Lock-up clutch control valve

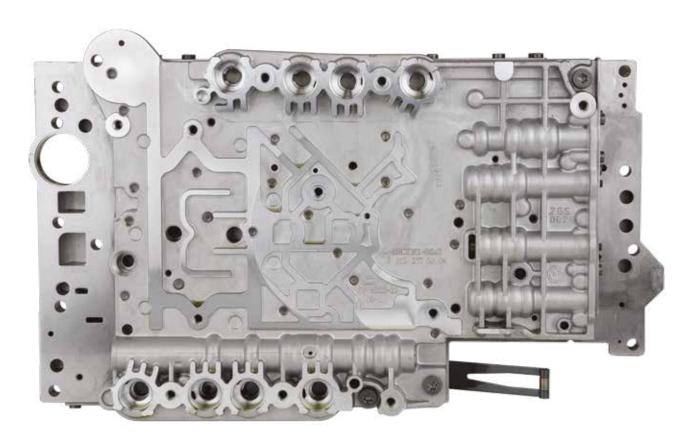
The valve body: a labyrinth of fluid lines, consisting of 2 metal housings and a dividing plate.

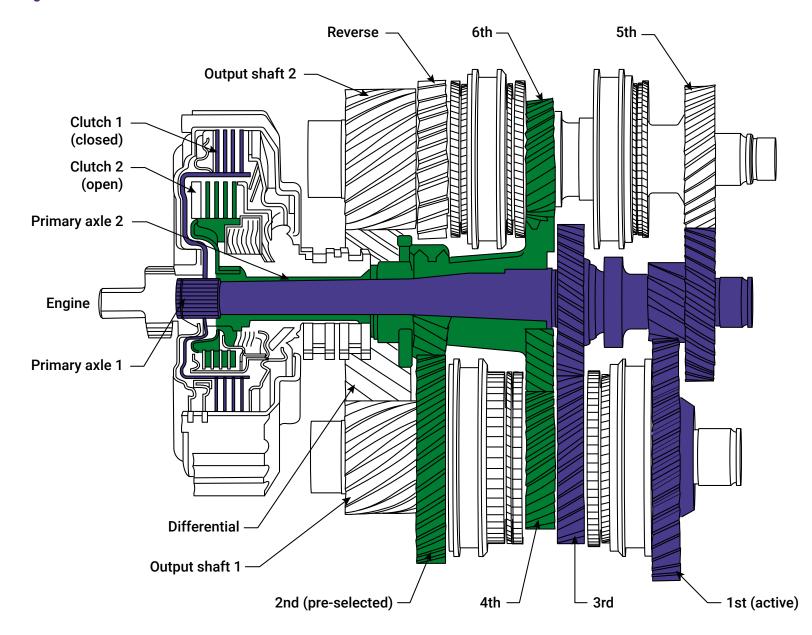
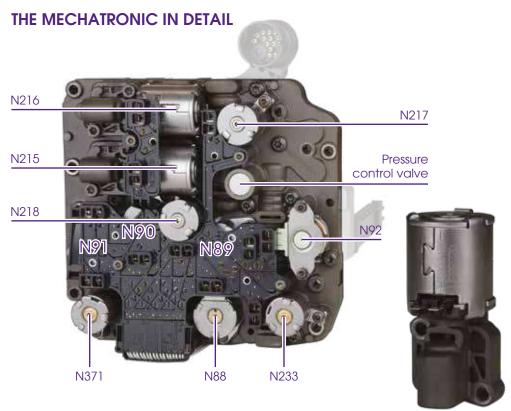
Schematics of a DSG 6 gearbox

Actuator	Function
N88	Shift valve for shifting 1st and 5th gears
N89	Shift valve for shifting 3rd gear and neutral
N90	Shift valve for shifting 2nd and 6th gears
N91	Shift valve for shifting 4th and reverse gear
N92	Switching valve for the multiplexer
N215	Pressure control valve for clutch K1
N216	Pressure control valve for clutch K2
N217	Main pressure control valve
N218	Pressure relief valve for the clutch cooling oil
N233	Safety valve for sub-gearbox 1
N371	Safety valve for sub-gearbox 2

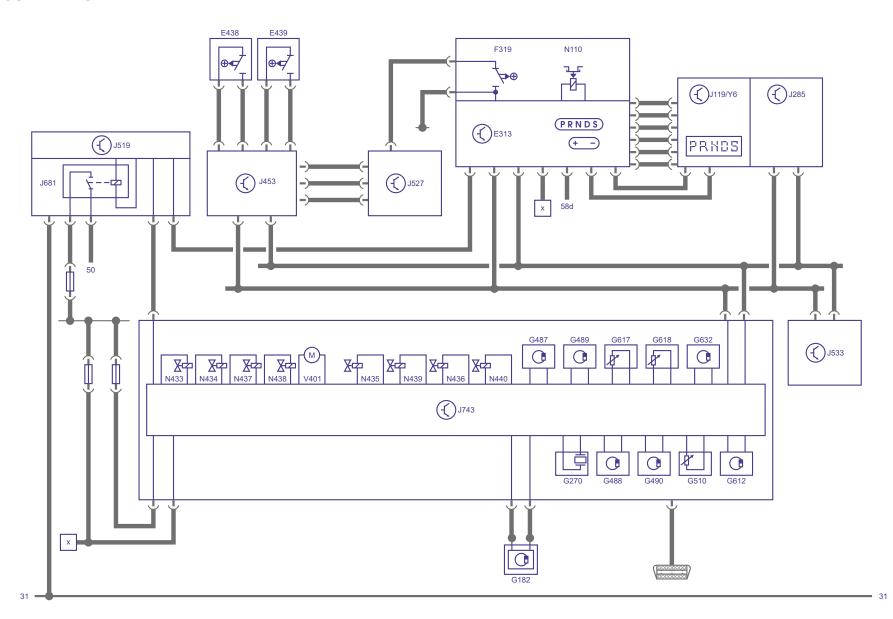
ELECTRIC SCHEMATIC

E313	Gear selector lever
J104	ABS (with EDL) control device
J248	Control unit for diesel direct injection
J285	Control unit for display instrument panel
J453	Control unit for multifunction steering wheel
J519	Control unit for electrical installation
J527	Control unit for steering column electronics
J533	Diagnostic interface for data bus
J623	Engine control unit for diesel engines

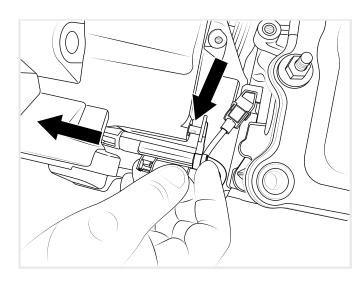
- 7. Put the speed sensor back in position. The clip must not be broken and the sensor must be completely attached to the housing as shown by the arrows in the illustration.
- 8. Remove the bleed plug and replace the original bleed plug.
- 9. Click the plug back onto the Mechatronic.
- 10. Refit the cable supports

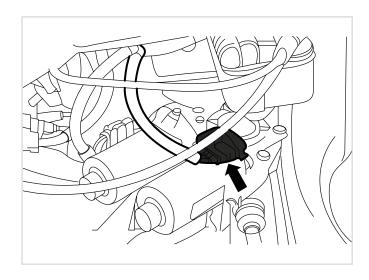
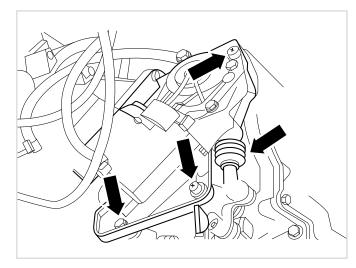
2. Disconnect both plugs from the shift actuator: the black plug is on top of a shift motor, the grey plug is blocked on the side of a shift motor. See illustrations above.
