# DIAGNOSTIC GUIDE TRANSMISSION CONTROL UNIT

# ALL RELEVANT INFORMATION IN ONE GUIDE

# EDITION 1

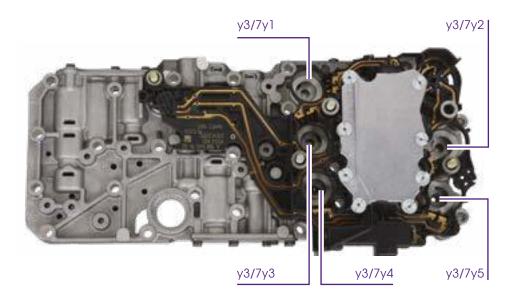
# THE MECHATRONIC IN DETAIL

Function
Control valve "for 1st and 4th gear"
Control valve "for 3rd gear"
Control valve "for 2nd, 5th and "R" gears"
Control valve for lock-up
Shift valve

The shift diagram can also be used for diagnostic purposes. If, for example, the car does not want to shift to 3rd gear, this could be due to clutch K3, but of course also to a defective control valve. In this case, Y3/7y2 is the valve that has to be additionally switched. By changing the position of this control valve, the complaint (and corresponding error codes) should move to the new position. Unfortunately, the control valves cannot be extensively tested using diagnostic software.

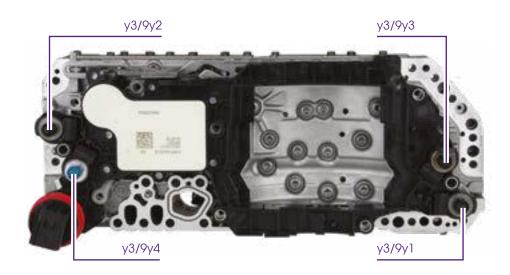
# THE MECHATRONIC IN DETAIL

Actuator	Function
Y3/9y1	Control valve for primary pulley
Y3/9y2	Control valve for secondary pulley
Y3/9y3	Control valve for clutch
Y3/9y4	Control valve for lock-up

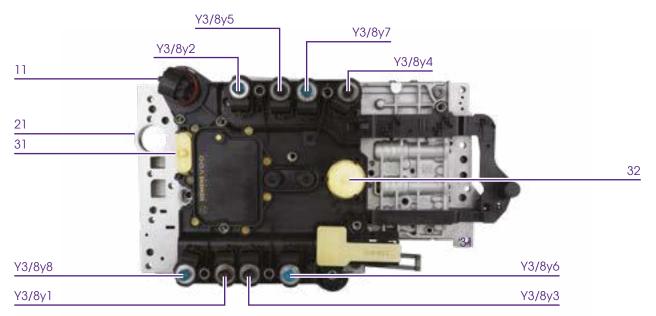
## THE MECHATRONIC IN DETAIL

Part no.	Function
11	Plug
21	Hydraulic block / valve body, consisting of 2 parts and a partition panel
31	Oil level float 1
32	Oil level float 2
Y3/8y1	Control valve for general operating pressure
Y3/8y2	Clutch control valve K1
Y3/8y3	Clutch control valve K2
Y3/8y4	Clutch control valve K3
Y3/8y5	Brake control valve B1
Y3/8y6	Brake control valve B2
Y3/8y7	Brake control valve B3
Y3/8y8	Lock-up clutch control valve

A car with a 722.9 gearbox does not want to shift up any further than 2nd gear. 3rd gear cannot be engaged and the vehicle shoots into limp mode. The diagram shows that multi-plate clutch K1 should be officially enabled by control valve Y3/8y2. In the absence of error codes that specifically indicate a defective TCU or control valve, it can in this case be concluded that multi-plate clutch K1 is very likely to be defective.

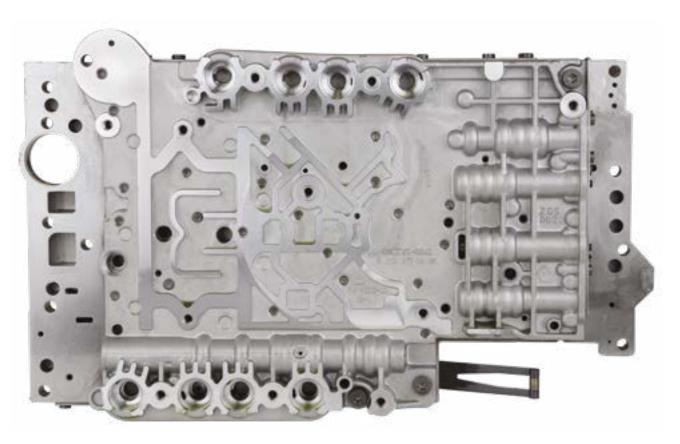
The valve body: a labyrinth of fluid lines, consisting of 2 metal housings and a dividing plate.

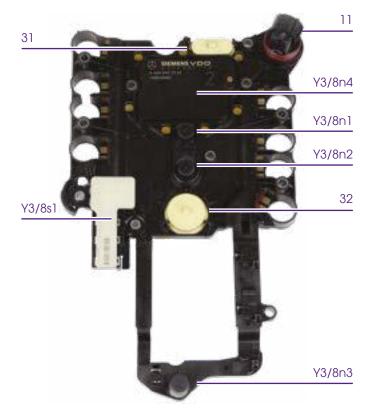
## THE TCU IN DETAIL

Sensor	Function
Y3/8n1	Input shaft speed sensor
Y3/8n2	Central speed sensor
Y3/8n3	Output shaft speed sensor
Y3/8n4	Control module
Y3/8s1	Position sensor switching position
31	Oil level float 1
32	Oil level float 2
11	Plug

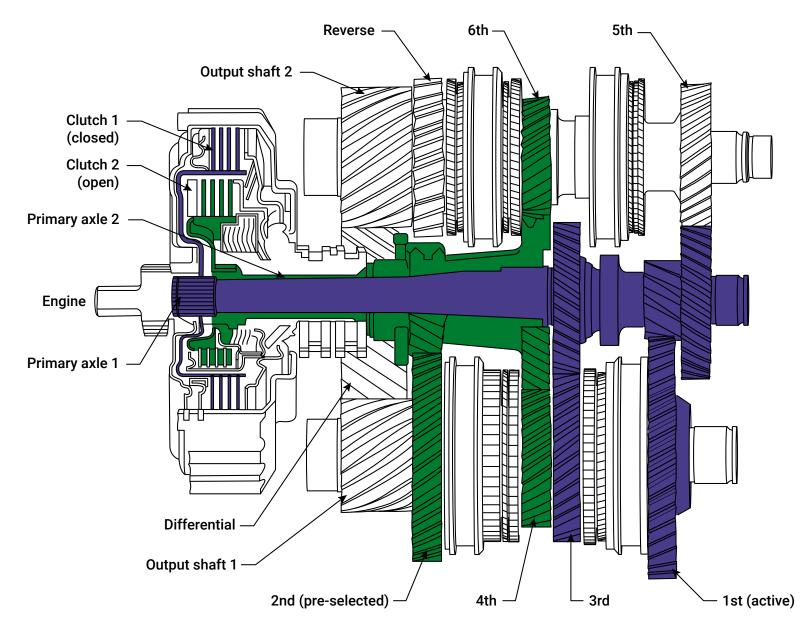
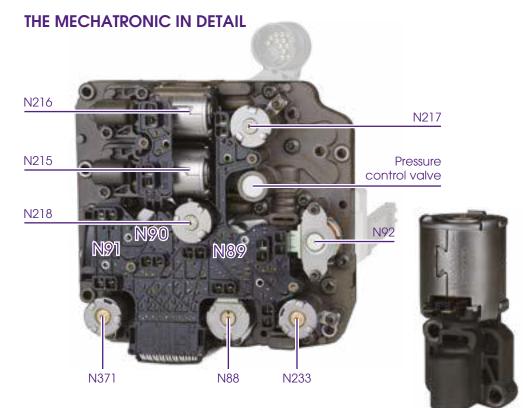
## Schematics of a DSG 6 gearbox

Actuator Function N88 Shift valve for shifting 1st and 5th gears N89 Shift valve for shifting 3rd gear and neutral N90 Shift valve for shifting 2nd and 6th gears N91 Shift valve for shifting 4th and reverse gear N92 Switching valve for the multiplexer N215 Pressure control valve for clutch K1 N216 Pressure control valve for clutch K2 N217 Main pressure control valve N218 Pressure relief valve for the clutch cooling oil N233 Safety valve for sub-gearbox 1 N371 Safety valve for sub-gearbox 2

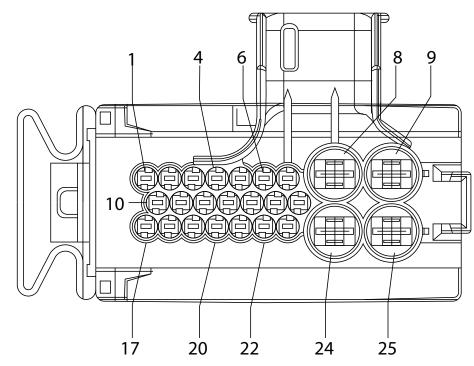
Connector on harness side.

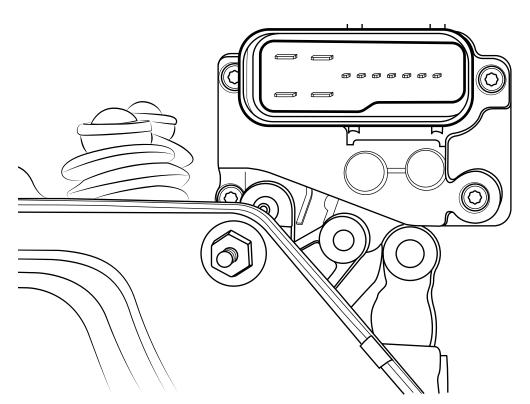
Connector on DSG 7 side.

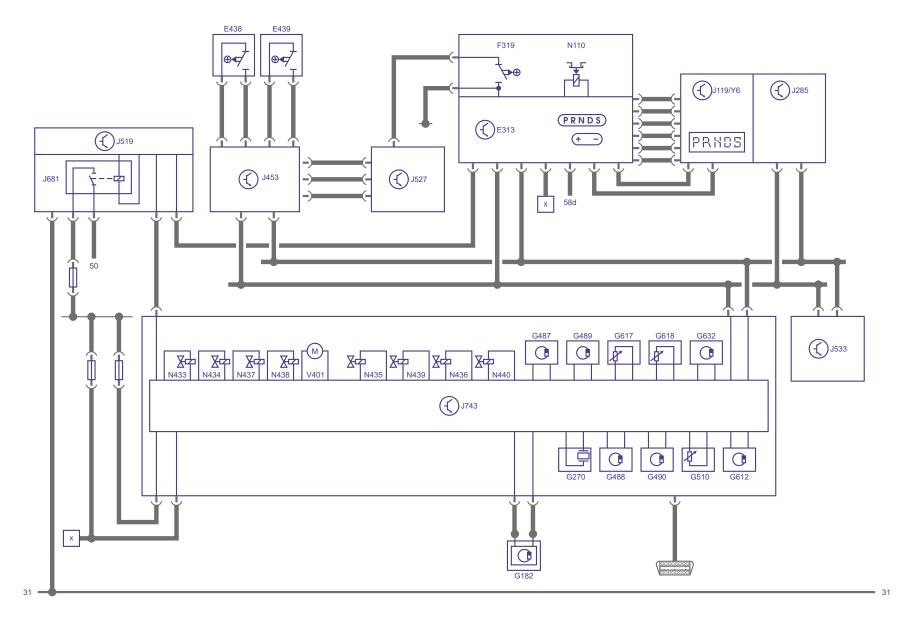
## **ELECTRIC SCHEMATIC**

- E313 Gear selector lever
- J104 ABS (with EDL) control device
- J248 Control unit for diesel direct injection
- J285 Control unit for display instrument panel
- J453 Control unit for multifunction steering wheel
- J519 Control unit for electrical installation
- J527 Control unit for steering column electronics
- J533 Diagnostic interface for data bus
- J623 Engine control unit for diesel engines

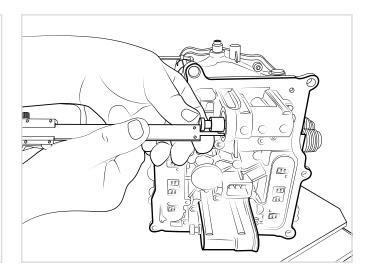
- 3. Check that the 4 tappets of the Mechatronic all protrude by 25 mm, see dimension "a" in the illustration.
- 4. Check that the seal of the Mechatronic is undamaged and leak-proof.

If the Mechatronic is remanufactured by us, we always send a tool (in the form of a black bushing) to help with point 3. This tool can be slid over the tappet. The tool will then always depress the tappet to the correct length.

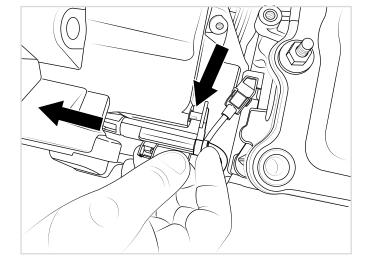
7. Put the speed sensor back in position. The clip must not be broken and the sensor must be completely attached to the housing as shown by the arrows in the illustration.

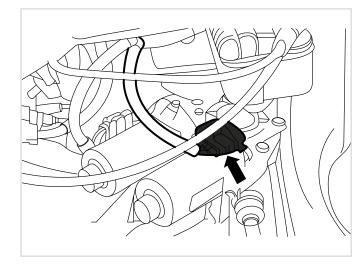
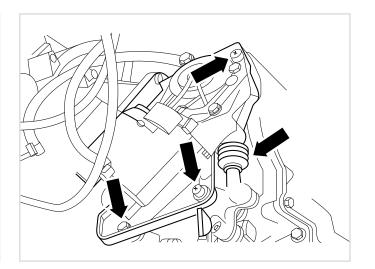
2. Disconnect both plugs from the shift actuator: the black plug is on top of a shift motor, the grey plug is blocked on the side of a shift motor. See illustrations above.
